Manhole Inspection Summary

Manhole # S29E__057MH

Insp Date: **9/25/08 8:31 AM**

Location Address: **220 N. Pine St**

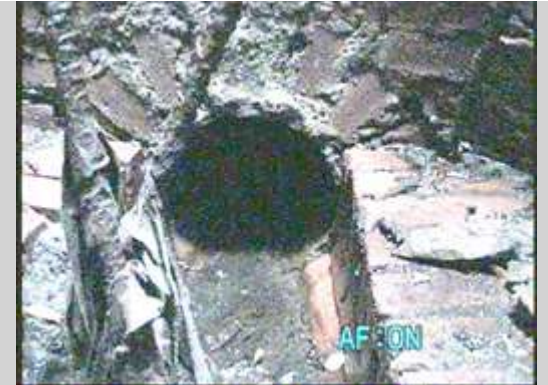
12 O'Clock Outflow

10 in. Circular Gravity Sewer
Pipe Out @ 12 O'Clock

Pipe Height: **8.4** (in.) Rod and Bar (Angled)
Pipe Material: **Clay** ☐ Pipe Lined
Invert Depth: **10.10** (ft.) Flow Characteristics: **Slow**
Deposits: ☒ None ☐ Mud ☐ ~~Gravy~~ ☐ **Debris** ☐ Grease
Silt Depth: **0** (in.) Deposits Extent:
Infiltration: **None** Pipe Seal Cond: **Sound**
